# BELZONA ELIMINATES BREACHES IN BLAST FURNACE

ID: 1371

Shaft for the Flow Control Gate into the blast furnace.

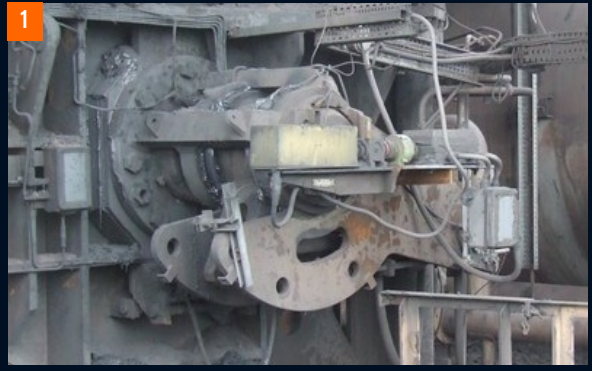
1. Blast Furnace Flow Control Gate assembled
2. Damaged shaft
3. Application of Belzona 1111 and clamp former
4. Final dressing of Belzona 1111 before reassembly

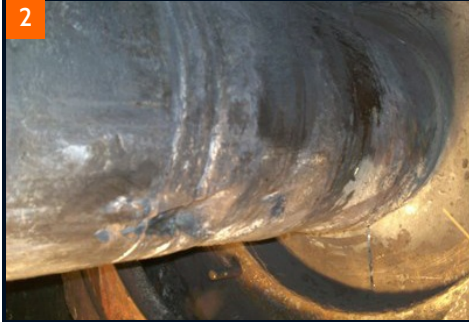
Abrasive dust and gases from the blast furnace had bypassed packings and seals around the shaft for the flow control gate at the top of the blast furnace. Damage had rapidly escalated, creating several grooved rings and severely gouged pits up to 15mm deep, allowing gases to escape, creating a potentially toxic area.

The contractor completed the work throughout the night and under a tight schedule. 9Kg of Belzona® 1111 was used with a purpose built clamp to recreate the original shaft profile of 280mm diameter. The preparation and application took only 2.5 hours, followed by a 5 hour cure period using heating pads to accelerate the cure. The blast furnace was returned to service with minimum downtime and to the complete satisfaction of the client.
