# BELZONA REPAIRS CASTING DEFECTS

ID: 1375

This pump transfers sea water from Persian Gulf to the steel mill

Steel mill, Iran

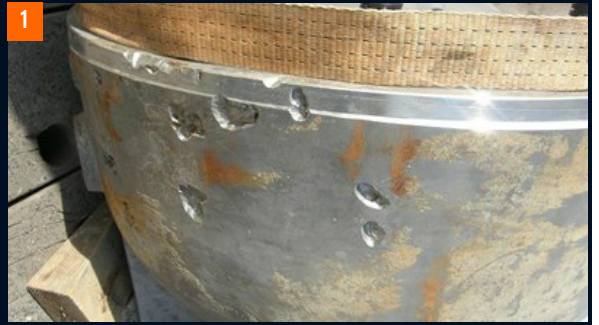
There were several holes on body and blade surfaces after 4 months working due to bad casting

1. Holes in pump body clearly visible
2. Rebuilding of impeller blades with Belzona 1311
3. Impeller coated with Belzona 1321
4. Pump body coated
