# BELZONA TO THE RESCUE ON-BOARD U.S. NAVY CARRIER

ID: 138

Marine evaporator doors on a Helicopter Carrier

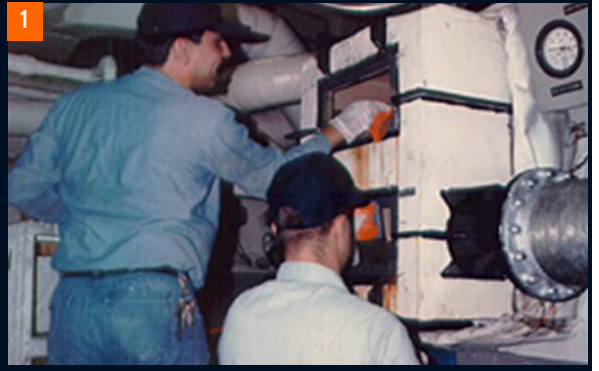
The evaporator doors were leaking and threaded holes in the evaporator casing for the door "hold-down" had badly corroded from contact with brine solution.

1. Applying Belzona 1111 to a flange
2. Inspecting the recently reformed flange surface
3. Forming custom gaskets in place with Belzona 2111

Application was carried out in accordance with Belzona Know-How Leaflets GSS-1 and GSS-8.
