# BELZONA KITCHEN REPAIR KEEPS THE STUDENTS GOING

ID: 1381

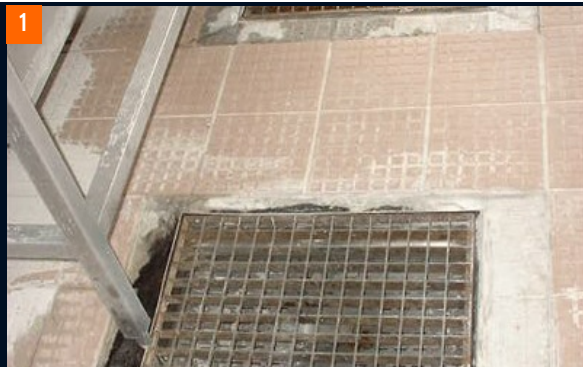
The tiles were degraded around the stainless steel grate. Following a health and safety inspection, the hygiene of the kitchen was reported so urgent action needed to be taken.

1. Application situation 1 before repair
2. Application situation 2 before repair
3. Application situation 1 after repair
4. Application situation 2 after repair

The application was carried out following the Belzona Know-How System Leaflet FPA-1.
