# BELZONA PROTECTS HEAT EXCHANGER TUBE SHEETS

ID: 1385

Heat exchanger tube sheets in Chemical plant.

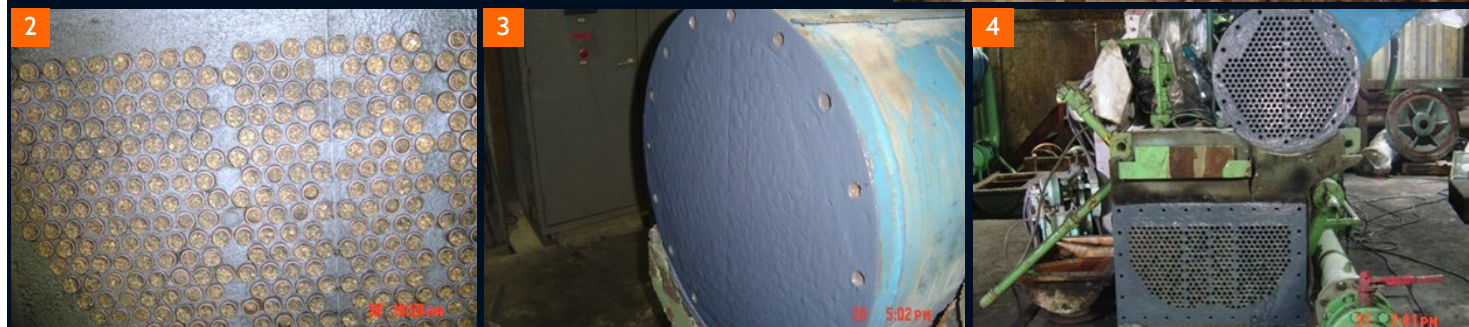
## PHOTOS

Erosion corrosion protection required on tube sheets to prevent further loss of metal that could otherwise lead to leakage, loss of efficiency and contamination.

1. Corroded tube sheet
2. After grit blasting
3. 1st coat of Belzona 1321
4. Completed application with corks removed from tubes

Application was carried out in accordance with Belzona System Leaflets HEX-1 & -3

Belzona 1111 (Super Metal)  
Belzona 1321 (Ceramic S-Metal)
