# BELZONA REBUILDS BEARING PLATES ON VERTICAL BORER

Craven 90" dia. Vertical Borer

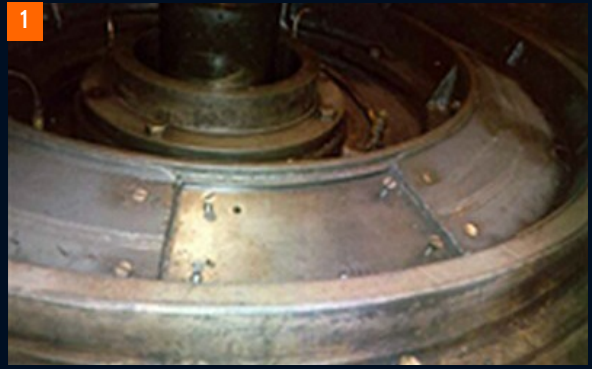
White metal bearing plates badly worn/scored due to oil starvation. Manufacturer of this unit has ceased trading so replacement part is unobtainable.

1. The problem area - excessive wear to white metal plates.
2. Application of Belzona 1131.
3. Chuck going back into machine to form Belzona 1131.
4. The finished job with oil grooves cut into Belzona 1131.
