# BELZONA REPAIRS LARGE SPOOL PIECES

ID: 1392

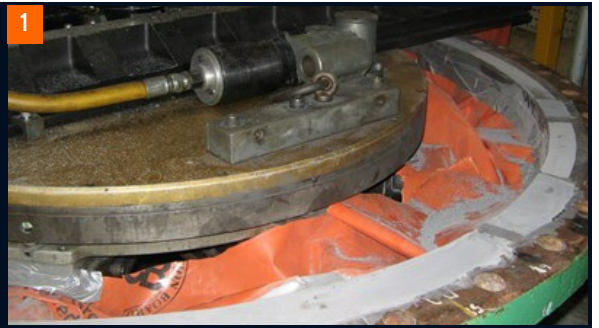
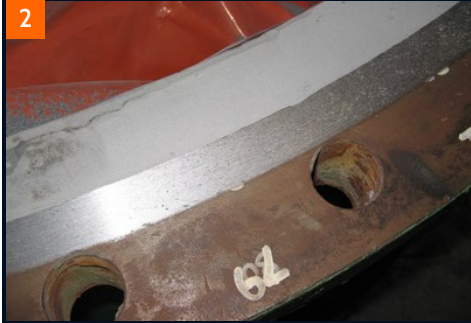
Damaged spool faces. Corrosion and distortion from weld stresses.

1 & 2 Pre-machined flange surface

An alternative repair material was used previously but had failed. The product was used to resurface the face of the spool where there was distortion.

Client had previously used an alternative product but had found that it could not withstand the weight of the valve spools on it. Using Belzona® 1111 the machined flange face can withstand immense compressive loads so providing for long term durable sealing.

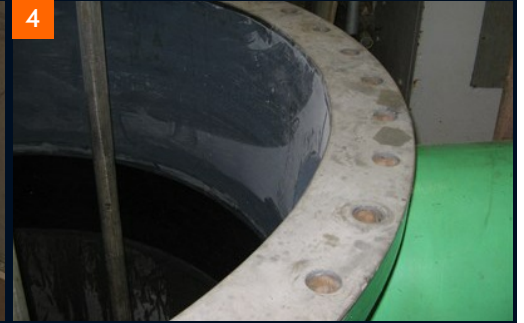
3 & 4 Finished machined flange faces

Application was carried out in accordance with a modified version of Belzona Know-How System Leaflet VPF-13.
