# BELZONA REPAIRS ACW PUMP

ID: 1393

Auxiliary cooling water pump

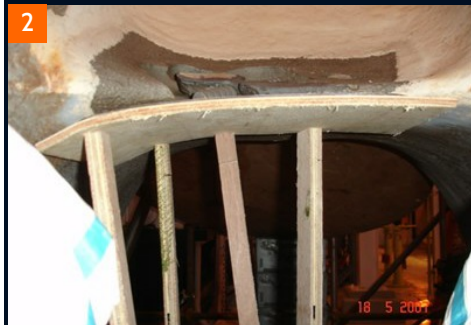
Severe abrasion damage to cutwater area of the pump meant loss of efficiency.

1. Damaged area with anchor pin in place
2. Former in position
3. Damaged area rebuilt with Belzona 1311
4. Finished job after application of Belzona 1321

Application was carried out in accordance with modified versions of Belzona Know-How system leaflets CEP-1 & -3. An anchor point was drilled and fixed through the casing. Belzona® 1311 was used to restore the required profile using timber formers to gain required shape. Belzona® 1321 applied to give area erosion corrosion protection.
