# BELZONA FIXES PILOT BOAT RUBBING STRIP

ID: 1394

Rubbing strip on Rigid Inflatable (RIB) pilot boat.

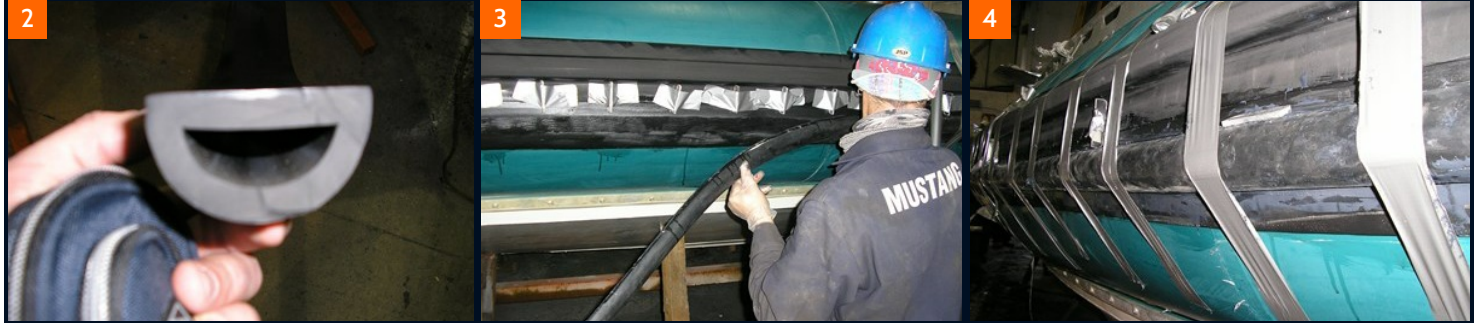
## PHOTOS

Due to the high cost of the new rubbing strip and the high cost of the boat being out of use, the client required a fast repair to put the boat back into service.

1. The RIB pilot boat
2. New D section rubbing strip ready to be bonded into place
3. Strip being bonded into place
4. New section bonded on and held in place with tape until Belzona cured

Application carried out in accordance with Belzona Know-How System Leaflet SOS-12. after preparing underside of rubbing strip and counterface on hull, the strip was positioned, spacers were used to ensure a level fit, and taped into place until Belzona cured.
