# BELZONA DOUBLES PUMP SERVICE LIFE

ID: 1395

## PROBLEM

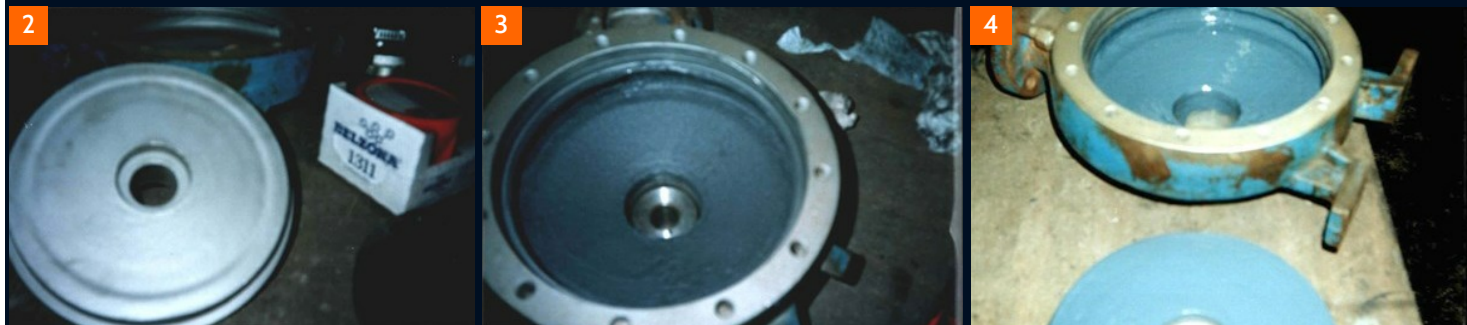
Due to crystallization of paraffin erosion-corrosion damage occurred on the case of the pump and cover. Acquisition of certain parts of the pump was not possible.

1. Grit blasted casing
2. Pump cover before rebuilding
3. Belzona 1311 applied to casing
4. Completed application

The application was carried out in accordance with Belzona Know-How System Leaflets CEP-5 and -3. areas were rebuilt using forming techniques.

Repair was done within 8 hours. In 3 days the pump was returned to service. Using Belzona allowed the customer avoid having to purchase new pump parts. this application increased average service life of such pumps from 4368 hours to 9168 hours.
