# BAROMETRIC CONDENSER PROTECTED WITH BELZONA

New Barometric Condenser for Major East Coast Oil Refinery

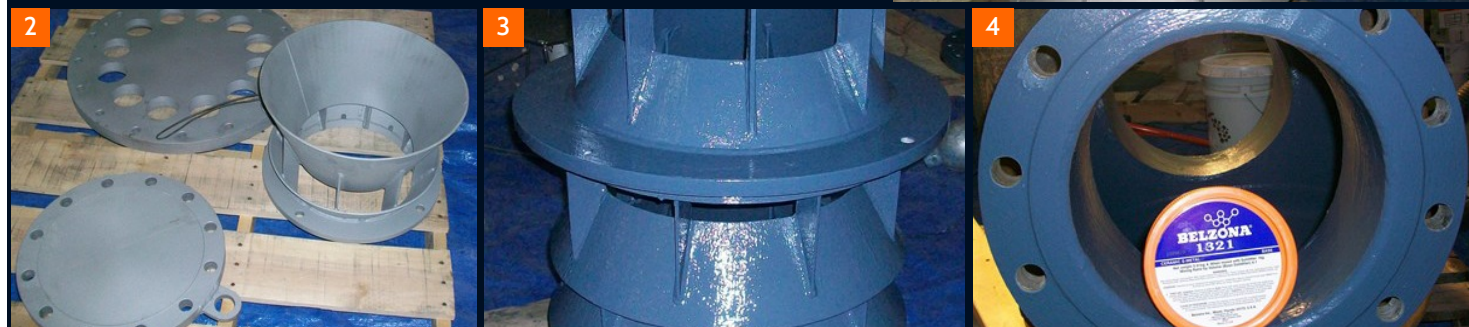
## PHOTOS

1. White metal blast
2. Additional components after blasting
3. Condenser coated
4. Coated flange face

Previous uncoated condenser was destroyed by erosion/corrosion. A new condenser was manufactured and the decision made to protect it with Belzona.

Application was carried out in accordance with Belzona Know-How System Leaflet HEX-3.

Belzona 1321 (Ceramic S-Metal)
