# BELZONA SEALS JOINTS ON COOLING TOWER

ID: 14

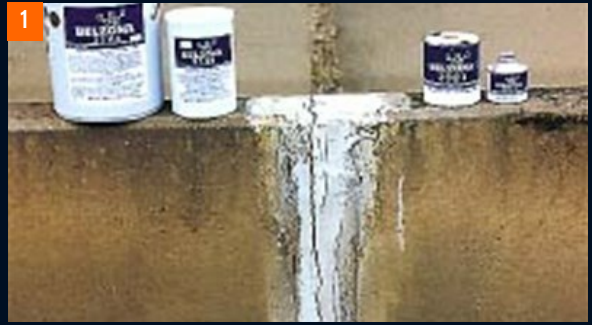
Leaking joints prevented tower de-icing system to function properly, resulting in ice damage to concrete tower.

1. The damaged expansion joint sealant.
2. Application in progress.
3. All joints sealed.
