# BELZONA REPAIRS HOLED CLARIFIER

ID: 1402

Waste Water tank at a Chemical Plant

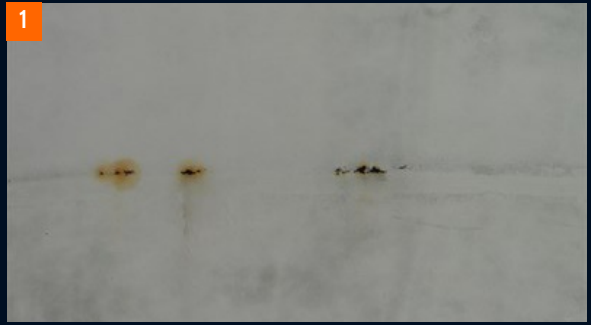
Corrosion along the water line had resulted in a series of holes and thin areas around the entire circumference of the tank.

1. Holes in tank wall
2. After grit blasting supports were bonded with Belzona 1211
3. Belzona 1121 being applied to shell
4. Exterior completed
