# BELZONA SAVES MONEY ON OIL-COOLER REPAIRS

ID: 1404

Nuclear Power Plant, Russia

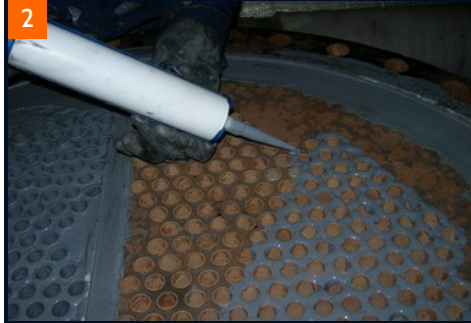
Due to the high temperature liquids, the sealing areas were eroded and corroded. Flanges, tubesheet and water box have been further damaged by corrosion.

1. Corroded tube sheet before application
2. First coat of Belzona 1391
3. Forming of sealed faces
4. Rebuilding water box division bar with Belzona 1111
