# BELZONA EXPANSION JOINT THREE YEARS ON

ID: 1405

Expansion joint in hallway.

Hospital, Charlotte, North Carolina, USA

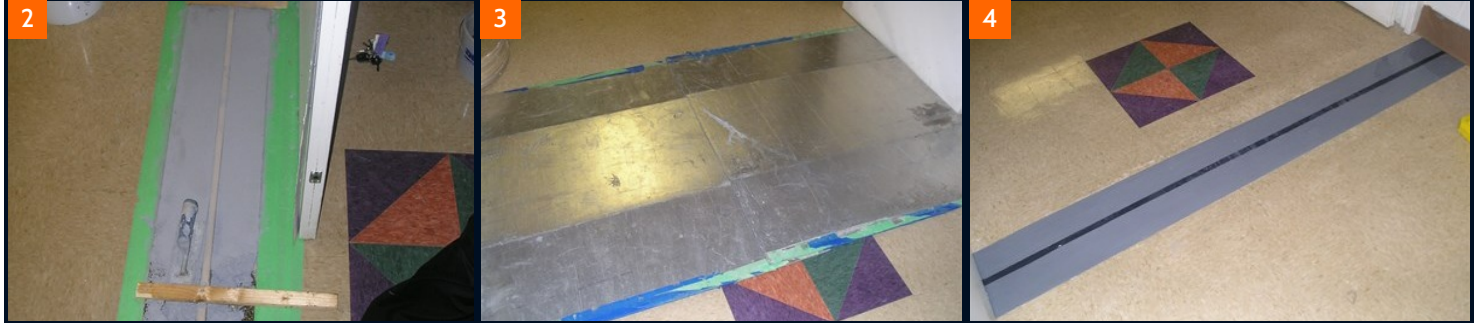
## PHOTOS

The expansion joint had failed and was causing a trip hazard, as well as making hospital guests uncomfortable when rolled in their beds or wheelchairs across the failed joint. Metal plate put over top was a trip and bump hazard.

1. Joint taken out and fresh concrete exposed
2. Belzona 4111 troweled into place
3. Ramp used to cover joint while product is curing
4. Finished joint 3 years on

The Belzona application was carried out in accordance with Belzona Know-How System Leaflets FPA-5 & -6. The old metal joint was torn out and replaced with Belzona® 4111. A jig was used to provide the repair with the same height as the tile floor. After removing the joint former, Belzona® 2211 was used to seal the joint. Belzona® 4411 applied for aesthetics.
