# BELZONA REPAIRS RUBBER LINED SLURRY PUMPS

Lime Slurry Pumps at this coal fired power plant.

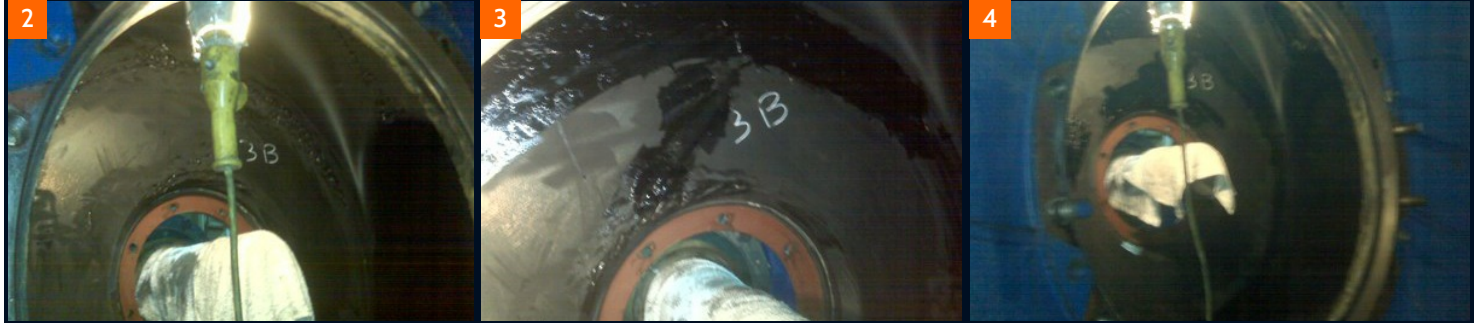
## PHOTOS

Areas on the inside of the pump were gouged and worn by the lime slurry.

1. The pump to be worked on
2. Damage caused by the lime slurry
3. Close up of Belzona 2111 repairs
4. The pump with the repairs completed

The application was carried out in accordance with Belzona Know-How System Leaflet SHM-11. The substrate was roughened using a rotary wire brush and scuffing tool. The damaged areas were conditioned and then the Belzona® 2111 applied to restore profiles.
