# BELZONA SOLVES KITCHEN TRIP HAZARD

ID: 1408

Hospital, Charlotte, North Carolina USA

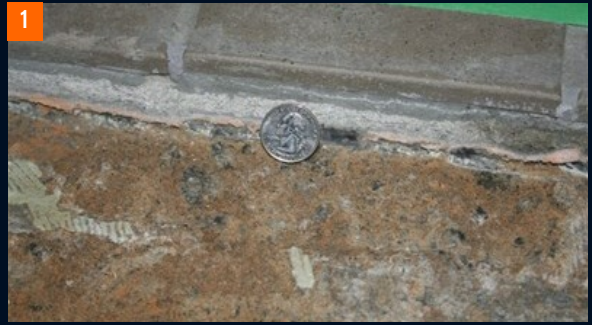
There is a big transition which was causing a trip hazard as well as limiting cart traffic.

1. Coin shows the transition step
2. Exposed concrete after rubber floor removal.
3. Applying the Belzona 4111
4. The finished job
