# BELZONA LOW COST MAINTENANCE OF PRESS PADS

ID: 141

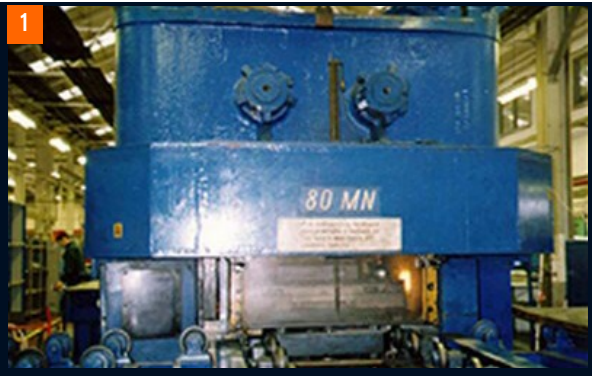
Rubber pad press used to form components from sheet metal. The rubber bolster exerts approximately 15000psi to the metal sheets to form them over the pattern die.

1. General view of the press
2. The resurfacing pad being positioned over the bolster with both surfaces treated with Belzona 2131
3. Weights in place whilst Belzona 2131 cures

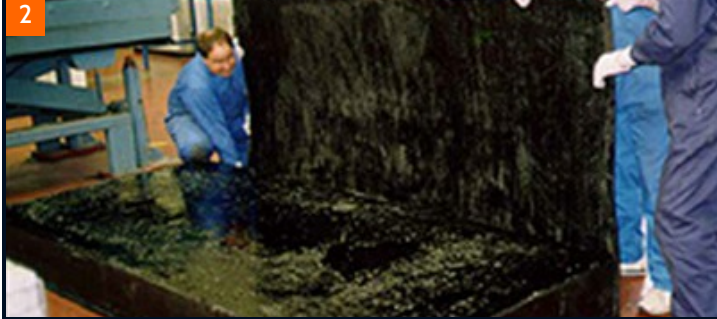
Wear and cutting of the rubber bolster during the forming process leading to loss of accuracy in the formed components.

Instead of replacing complete bolster a 1-inch (25 mm) thick rubber pad is bonded to the surface in accordance with Belzona System leaflet GSS-2.
