# BELZONA KEEPS METAL CHURNING

ID: 1410

Magnetic Cylinder, called a Stirring Jacket, used to mix molten Titanium.

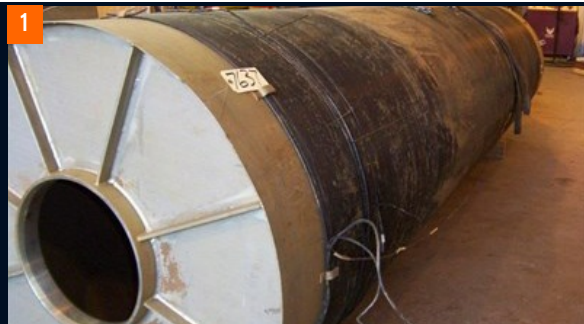
Electrical shorts in the coil wrapped around the cylinder caused a loss of current responsible for producing the magnetic field used to stir the molten titanium.

1. Stirring jacket wrapped in coil.
2. Cylinder prepared ready for application of first coat.
3. First coat being applied.
4. Cylinder after 18 months still "churning" away.

Application was carried out in accordance with Belzona Know-How System Leaflet GSS-1. Approximately one mile of #6 wire which supplied the current was removed. After surface preparation, one coat of Belzona® 2221 was applied, the coil was then re-wrapped, and a further coat of Belzona® 2221 was applied over the coil.
