# CAVITATION PROTECTION FOR WATER PUMPS WITH BELZONA

ID: 1414

End suction centrifugal Water pumps

Water treatment plant, Egypt

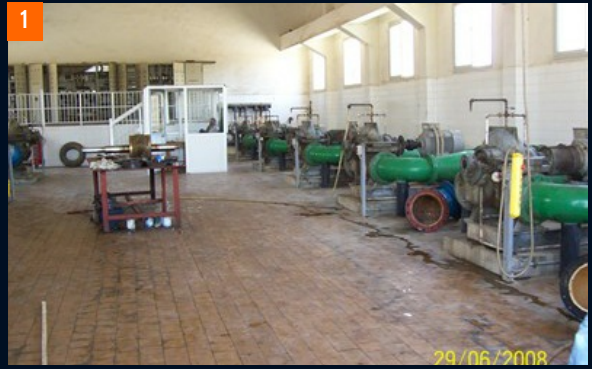
1. General view of the pumps
2. Erosion/Corrosion damage
3. The cavitation area after blasting
4. Completed application

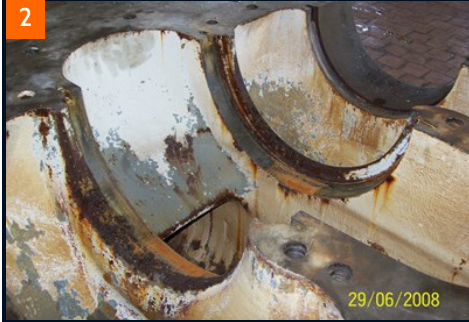
General erosion/corrosion damage and severe cavitation leads to reduced pump efficiency.
