# BELZONA PROTECTS AMINE STRIPPER COLUMN

ID: 1416

Amine stripper tower (Diglycolamine "DGA") operating at 115°C.

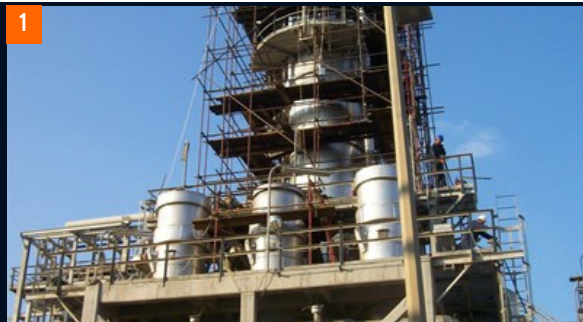
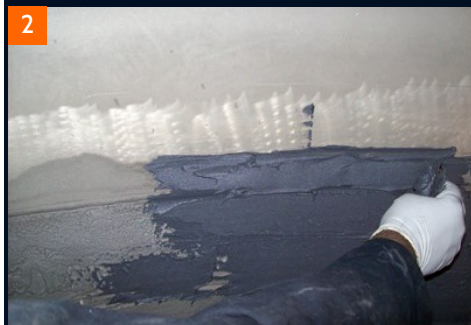
Corrosion had led to a reduction in the wall thickness, forcing a shutdown.

1. General view of the column 2. Application of Belzona 1511 to grit blasted substrate 3. Finished application after pinhole inspection 4. Inspection after 3 years service.

Belzona offered a corrosion resistant system for the hot chemical process involved. Metal cladding could not be carried out within the time constraints of this short shutdown. Inspection after 3 years service showed the coating to be in excellent condition.
