# BELZONA REPAIRS CASING OF A CEMENT BALL MILL

ID: 1417

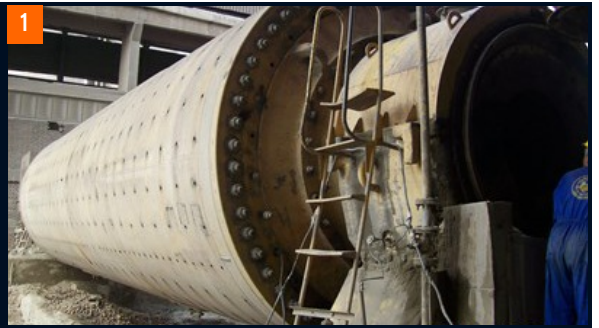
1. General view of the mill.
2. Wear on the shell after dismantling the plates.
3. Application of Belzona 1121.
4. Completed application.

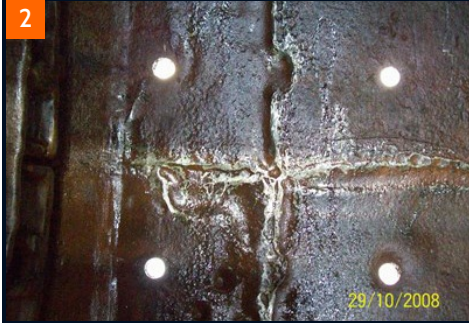
Wear on the casing needed to be rebuilt before the bolting of the new wear plates.
