# BELZONA FACTORY APPLIED TO CHILLER

ID: 1418

A customer buying a new chiller requested a Belzona coating to protect their investment.

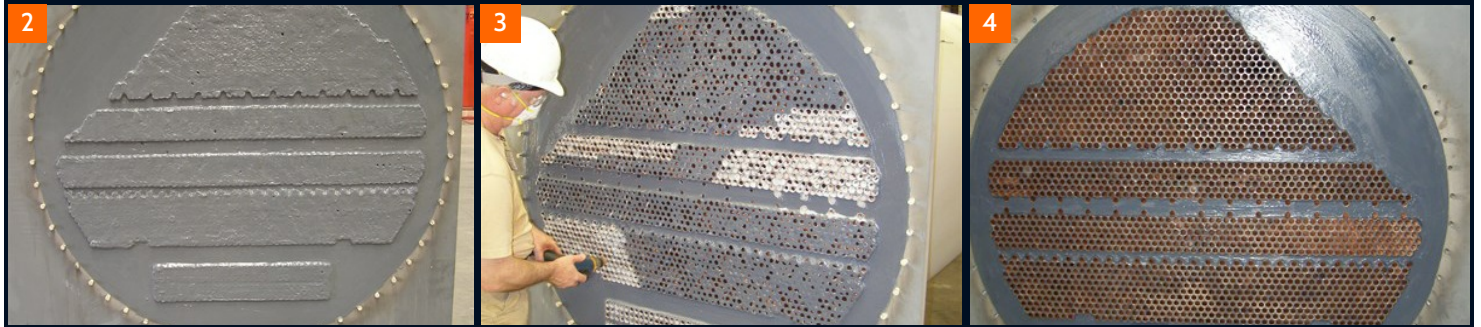
1. Corking of the tube sheet
2. Built-up tube sheet with one coat of Belzona 1321 applied
3. Corks punched in and tube ends being honed
4. Completed tube sheet

Application carried out in accordance with Belzona Know-How System Leaflets HEX-1 & -3. After corking tubes, Belzona® 1111 used to ensure the tubes are flush with the surface before applying the Belzona® 1321 system.
