# BELZONA RESTORES COOLING WATER PUMP

ID: 1419

Main circulating water pump at refinery.

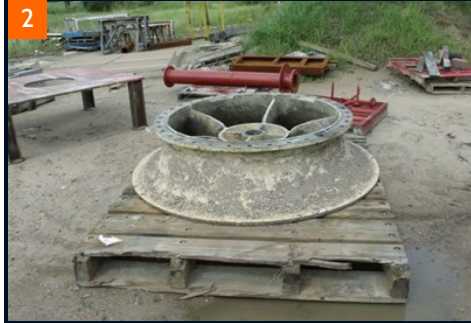
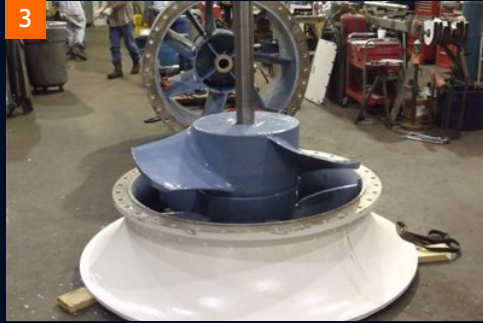
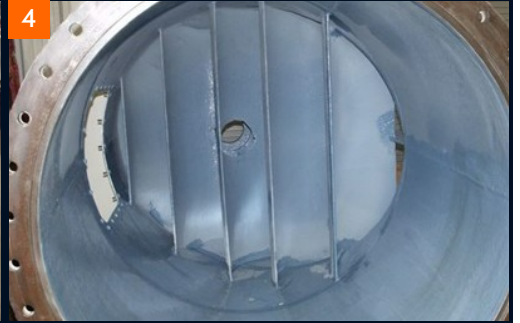
General corrosion over many years had degraded the operation of the pump.

1. Circulating water pump
2. Damaged suction bell
3. Impeller coated with Belzona 1341 together with rebuilt and coated suction bell
4. Pump discharge coated with Belzona 1341

Application was carried out in accordance with Belzona Know-How System Leaflets CEP-1 & -3. All pitting was rebuilt with Belzona® 1111. After the rebuild was complete two coats of Belzona® 1341 applied.
