# BELZONA REFURBISHMENT OF VACUUM PUMP

ID: 142

Siemens Elmo vacuum pump from drum filter

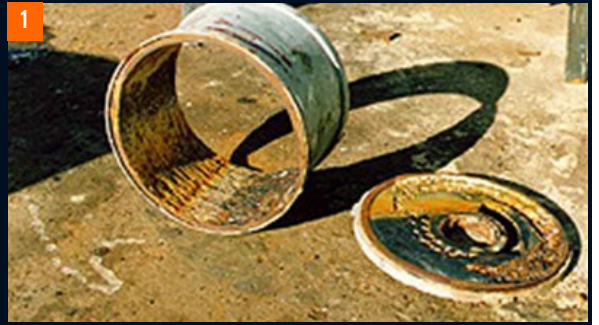
Severe erosion corrosion of port plates, body and rotor caused by poor quality sealing water resulting in corrosion, plus carry over of diatomaceous earth causing erosion.

1. The degree of erosion corrosion clearly evident on the port plates and body
2. The restored body
3. The coated rotor with reformed port plates in background

Application was carried out in accordance with Belzona Know-How leaflets PDP-5 and FBC-11. Port plates were restored by forming correct dimensions and critical areas on the body were re-built and machined to size before coating with Belzona® 1321
