# BELZONA EXTENDS LIFE OF MIXER BOWLS FROM ENGINE CASTING PLANT

ID: 1421

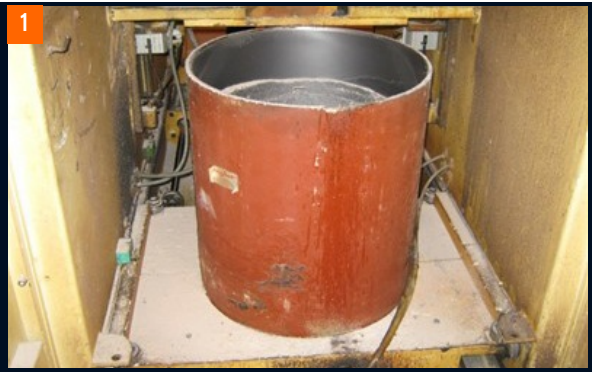
1. Working mixer bowl
2. Inner bore of worn mixer
3. New mixer bowl after machining
4. Completed application of Belzona 1812

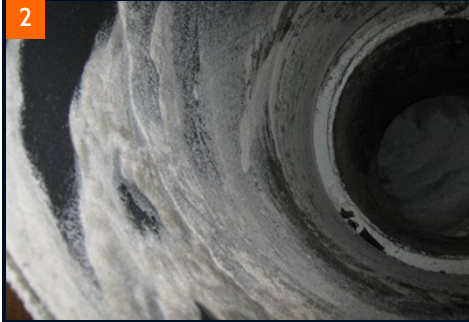
Inside surface of bowl was being eroded by the sand mixture. The bowl measures approximately 19 inches in diameter by 27 inches in length. The inner surface was being eroded by 1/4 inch during a 6 month period. The mixers handle up to 5.5 tonnes of sand per hour.
