# BOW THRUSTER REPAIR WITH BELZONA

ID: 1423

Bow thruster of cargo vessel

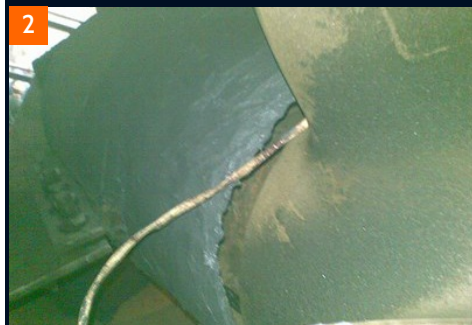
Erosion/corrosion effects made severe pitting damage to the whole bow thruster and supporting pillar due to bad cathodic protection.

1. General view of bow thruster
2. Belzona 1311 used to rebuild damaged surface and restore profile
3. First coat of Belzona 1321 applied
4. Second coat of Belzona 1321 applied to complete application
