# BELZONA REPAIRS SHAFT FROM CRUSHER

ID: 1427

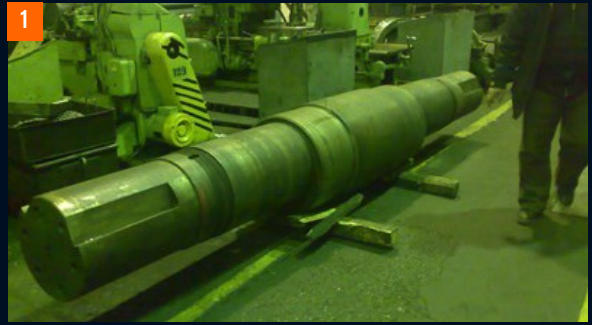
Shaft of 4.6 m length and weighing 7,2 tonnes from crusher which is critical part of the minerals plant.

1. General view of the eccentric shaft of crusher
2. Area before the application
3. After surface preparation application of Belzona 1111
4. Completed application

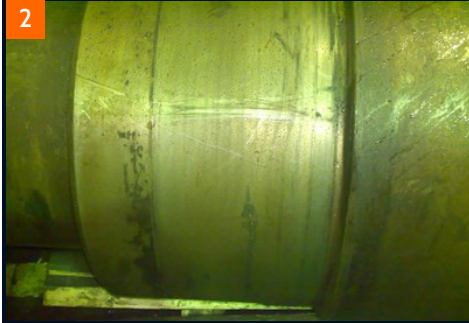
Failure of bearing caused it to spin on the shaft causing it to wear undersize.
