# BELZONA REPAIRS CONDENSOR WATER TUBES

ID: 1428

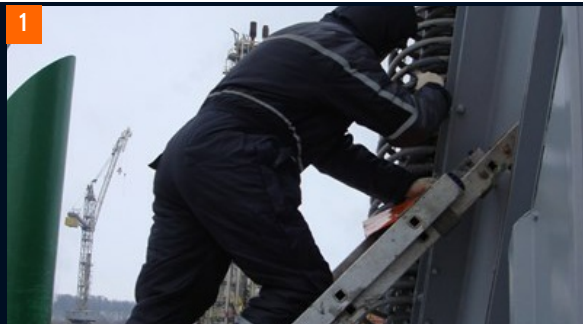
1. Removing loose material and paint
2. Surface preparation of the substrate
3. Application of Belzona 1111 with Belzona 9341 (Reinforcement Tape)
4. Belzona 1291 with tourniquet used to seal live leak
