# BELZONA REPAIRS AND REBUILDS POWER PLANT CONDENSER

ID: 1430

Tubesheet and waterboxes of power station condenser.

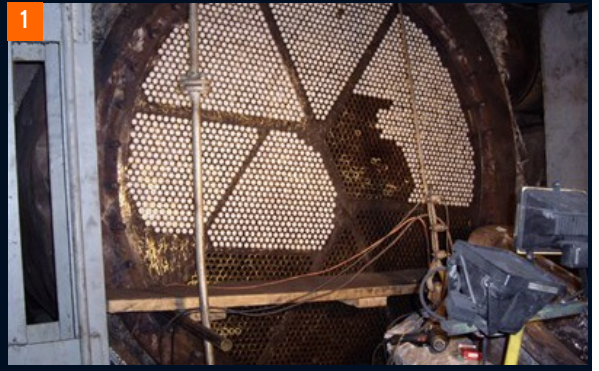
Inspection during the plant shutdown, showed severe corrosion on the heat exchanger with poor sealing on division bars and seal faces.

1. Surface preparation of tubesheet
2. Rebuilt and coated water box
3. Completed application to tubesheet

Application was carried out in accordance with Belzona Know-How System Leaflets HEX-1, 2 & 4.
