# ASSEMBLING PROPELLER RUDDER BEARING IN THE SHIP

ID: 1431

Two similar bearing lining applications completed in propeller rudder section.

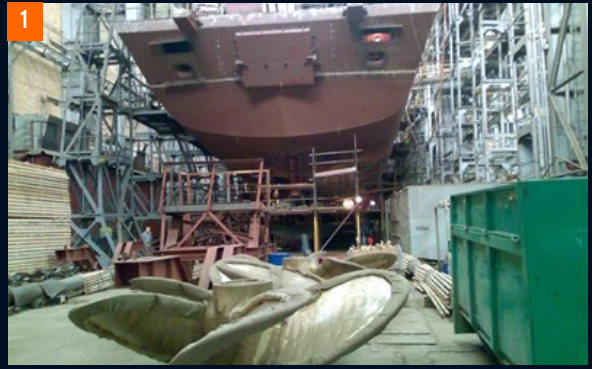
1. General back view of the ship
2. General view of a bracket with the exposed plug of the bearing
3. View of Belzona 1111 sealing between bearing lining and body frame of bracket before the injection
4. Injection of Belzona 1321
