# BELZONA SAVES FINE PAPER PUMP CASING

ID: 1432

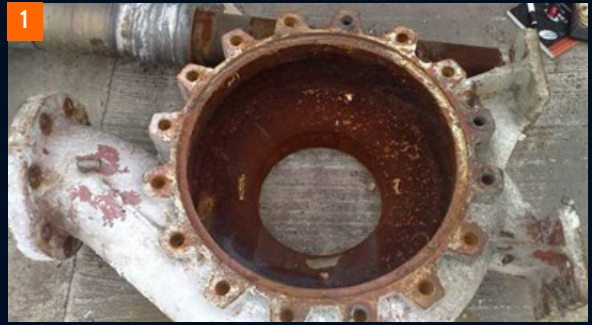
Badly corroded pump volute could not be put back in service in such bad condition

1. Corroded Pump Volute before application
2. Volute coated with Belzona 1321
3. The refurbished pump volute ready for service
