# CONVEYOR ROLLERS ON DREDGER RESTORED WITH BELZONA

ID: 1433

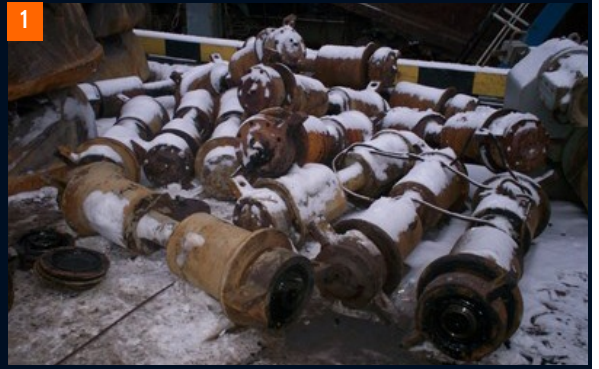
1. General view of dismantled rollers
2. View of the defects on the rollers
3. & 4. A completed application

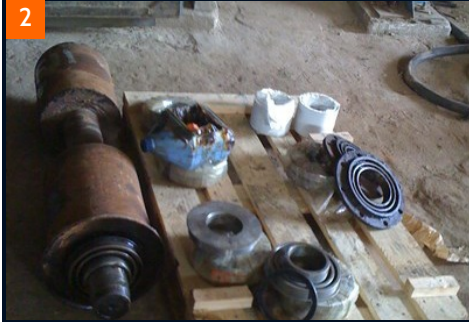
After dismantling, 17 rollers were revealed to be damaged especially bearings, shaft journal and mounting seats.
