# BELZONA RESURFACES BRAKE TEST ROLLERS

ID: 1435

Rollers of the Brekon 131-4S type car brake testing rig.

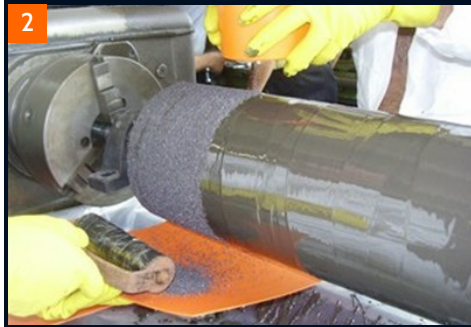
Worn original anti-slip coating on the brake rollers.

1. The worn brake test rollers
2. Application of Belzona Grip system
3. Completed application
4. Picture after 2 years in service and more than 12,000 brake tests

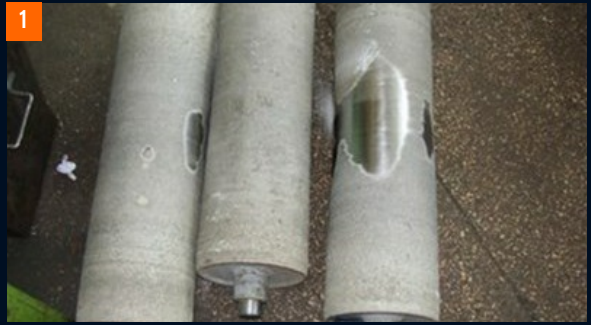
Belzona application avoided the replacement costs and outage of equipment. Between 2007 and 2009, more than 12.000 brake tests have been carried out, which was a very satisfactory result for the client. A Testimonial letter is available from the customer about this application.
