# BELZONA PROTECTS PROPULSION UNIT ON FERRY

ID: 1436

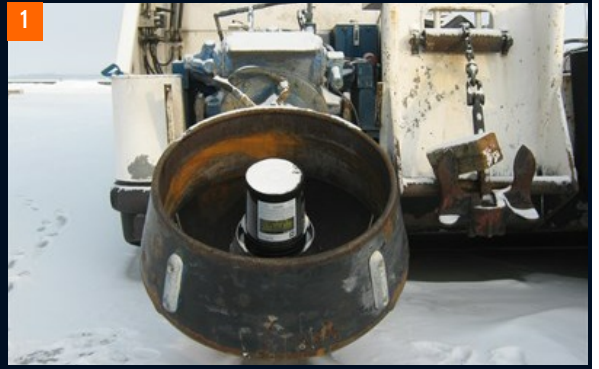
1. Rolls Royce drive unit on Ferry
2. Nozzle of drive showing corrosion and erosion from cavitation
3. Inner surface grit blasted and erosion damage built up using Belzona 1311
4. Application of Belzona 2141 completed

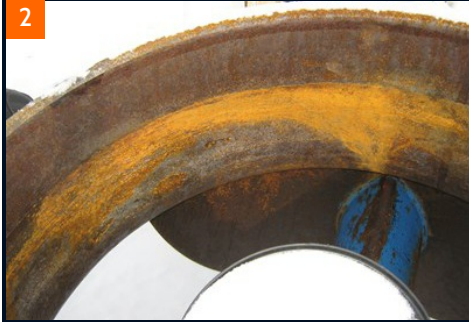
Erosion had worn through nozzle. Welding considered but high risk of distortion and expensive.

Nozzle of drive unit eroded due to cavitation.
