# BELZONA PROTECTS AUGER SCREWS AT CEMENT PLANT

ID: 1437

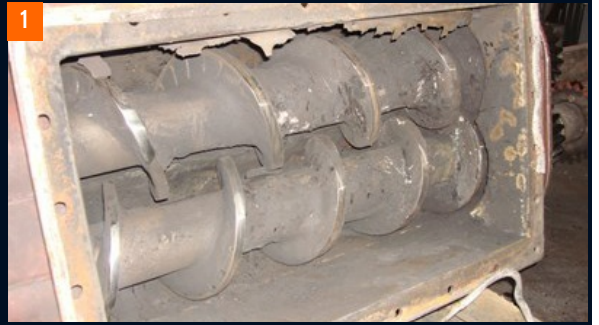
The auger screws suffer severe abrasion and client needed an effective protection system.

1. General view of screws after 1 year in service
2. The view after surface preparation
3. Belzona 1812 application on both sides of helical outer surfaces
4. Belzona 1321 application and completed job
