# BELZONA RESTORES PUMP FROM SUGAR MILL

ID: 1439

Customer looking to repair badly eroded back plate & volute and to coat new Impeller

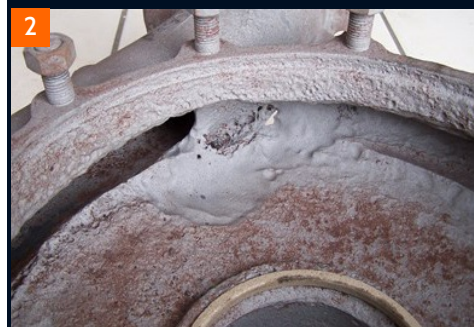
1. Pump after grit blasting
2. Badly worn cut water and hole through volute
3. Finished Application
4. Pump assembled and ready for despatch

Conventional weld repairs difficult on cast iron. Belzona provides effective rebuild and restoration of profiles without risk of distortion and Belzona® 1391 provides excellent erosion corrosion protection at the pumps 80 °C operating temperature.
