# BELZONA USED TO RESTORE CORRODED FLANGE ON CHIMNEY

ID: 144

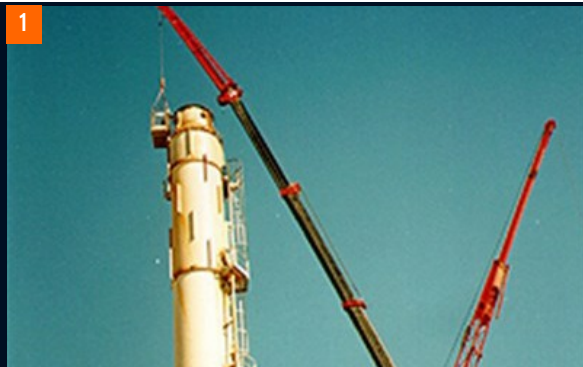
An acid vapour evacuation unit installed on top of a high chimney

1. The difficult working situation on the chimney
2. The flange rebuilt and protected
3. Belzona 2221 used to cast new gasket

Ease of use was an important factor given the difficult working situation. The excellent chemical resistance of Belzona® 4311 has prevented further corrosion occurring on the flange.

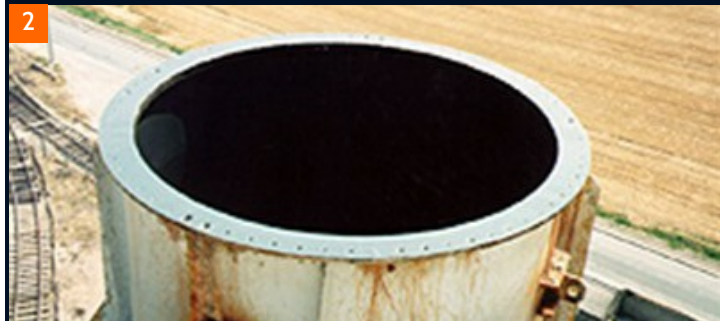
The flange faces and the removable gasket had been attacked and corroded by the chemicals passing through the unit. In places the depth of corrosion on the flanges was 20-30mm.

Application was carried out using suitably modified techniques covered in Belzona System Leaflets GSS-2, VPF-1, 2 & 13.
