# BELZONA PROVEN CAVITATION PROTECTION TO FRANCIS TURBINE

ID: 1441

Francis turbine runner, 800mm diameter, 40-50m head and optimum 600rpm. Power output 2.1MW with 4m<sup>3</sup>/s flow rate.

Hydroelectric plant, Slovakia

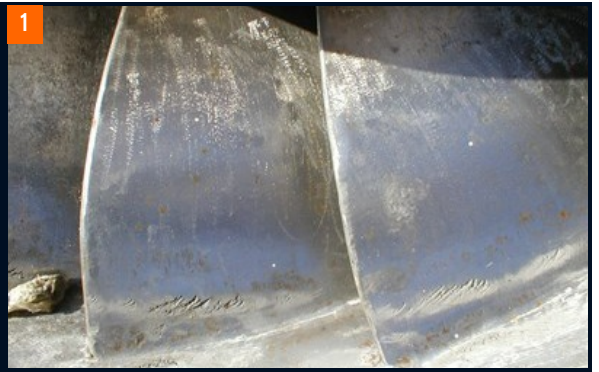
Cavitation had caused erosion of the metal and loss of turbine performance. Belzona® 1311 and Belzona® 1341 had been applied in 2004, but had suffered further cavitation, so system upgraded by applying more cavitation resistant Belzona® 2141.

1. Cavitation damage to turbine runner
2. Belzona 1341 showing some cavitation damage
3. Belzona 2141 being applied to the runner
4. After 24 months service Belzona 2141, inspection shows no further cavitation damage

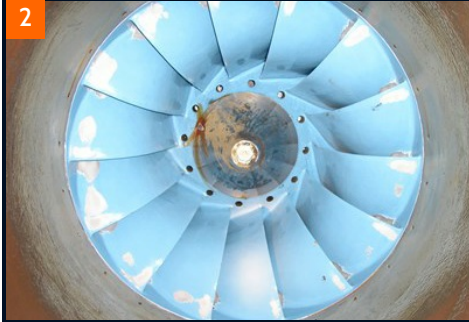
Inspection of the Belzona Ceramic coating in 2006 showed damage from cavitation, so specification was changed to Belzona® 2141. Further inspection after 2 years showed no damage on the turbine runner. In 2013 small areas of coating damage were repaired with further Belzona 2141.
