# BELZONA REPAIRS SPALLED CONCRETE

ID: 1442

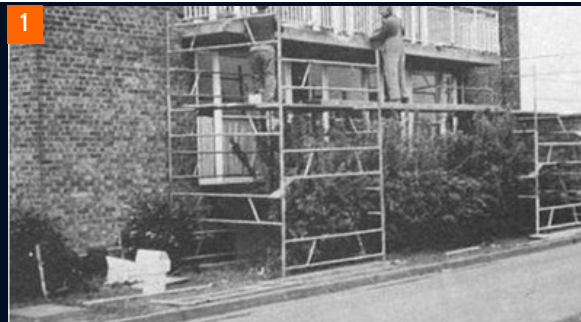
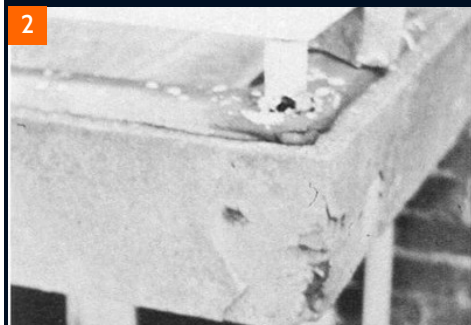
Concrete balcony had suffered from spalling due to the detrimental effects of the environment and concrete cover below the minimum for protection of the reinforcing bar.

Community College in 1980 - Spalled Concrete Community College (shown in image 1-2)

Application was carried out in accordance with Belzona Know-How System Leaflet RPA-2. Lightweight Belzona® 4141 system would now be specified as it requires no permanent shutter/formwork following Belzona Know-how System Leaflet WPA-4. This would have made the job even easier to carry out.

The initial application was quick and eliminated any potential safety risk due to unsafe concrete falling from the two storey building. Twenty seven years later, Belzona revisited the application to find that it was still in excellent condition with no signs of further spalling, carbonation, shrinkage or cracking. Now 40 years later Belzona has revisited the site again, and there are still no signs of further damage.
