# BELZONA PROVIDES ROOF PROTECTION

ID: 1443

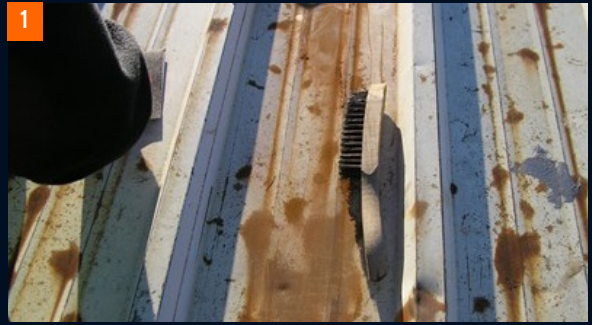
New extension was suffering from leaks due to attack from bird litter and excrement which was chemically attacking the plastic coated steel sections.

1. Corrosion issues due to bird litter on roof extension
2. 1990 application unaffected by bird litter
3. 2005 application completed
4. 2010 still is perfect condition

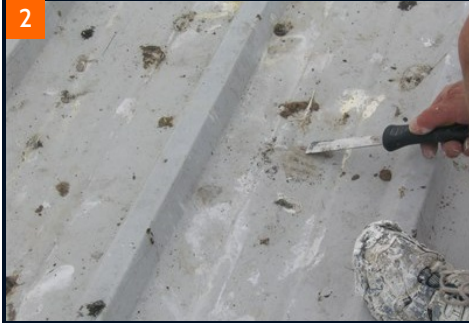
The original roof was completed in 1990 by the local Authorized Contractor. It was possible to see corrosion as a result of bird litter on sheets of the new extension but on the Belzona® 3111 Membrane System it has had no effect on performance although a wash would make it more aesthetically pleasing. As a result of the success on the original roof, the extended building was then encapsulated and the existing system refurbished to provide a further 15 years life.
