# BELZONA PROTECTS A POWER STATION CHIMNEY STACK

ID: 1444

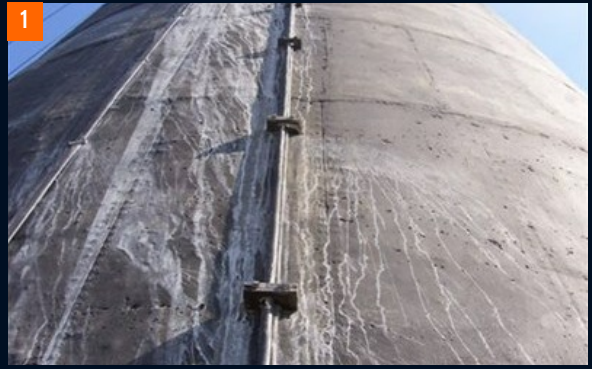
Existing coating was beginning to degrade due to exhaust gases and ultra-violet (UV) breakdown combined with inclement weather.

Existing coating degrading Application of Belzona 5111 Completed application in 2008 Application revisited in 2010

Application was carried out in accordance with modified Belzona Know-How System Leaflet WPA-2. Deteriorated bituminous coating was removed by grit blasting. Cracks and spalled concrete was rebuilt with Belzona® 4141 before coating with Belzona® 5111.
