# BELZONA 1391 PROTECTS ABSORBER TOWER

Absorber tower used to remove CO<sub>2</sub> from waste gases.

Steel producer in Indonesia.

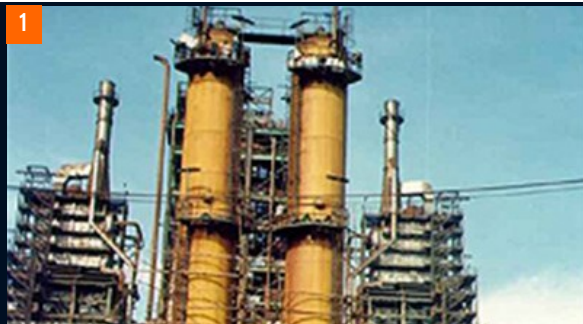
MDEA is used at a temperature of 120°C (250°F) in this absorber and severe corrosion is experienced.

1. General view of the absorber tower.
2. Work underway inside the absorber.
3. Application of Belzona 1391 by applicator.

Belzona chosen to repair critical areas as alternative to re-plating which was very much more costly and would have taken four times as long. Structure planned to be replaced after six months. In fact, replacement would have delayed for 12 months at which time Belzona® 1391 was still in perfect condition. Belzona® 1391 used on new absorber tower.
