# BELZONA REPAIRED STEPS IN GREAT CONDITION AFTER 5 YEARS

ID: 1458

Promenade steps on coast needing repairs.

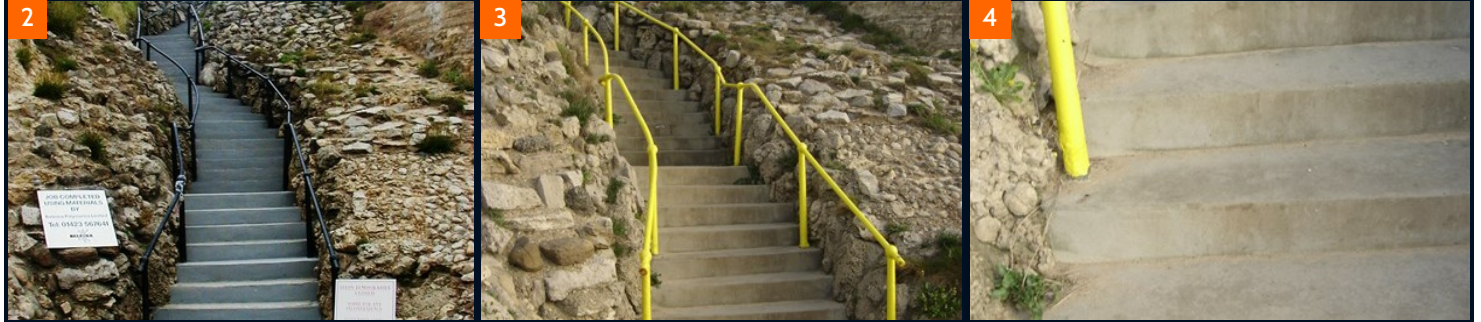
Due to the steps being on the sea front, over a number of years they had deteriorated where the nosings were damaged and in dangerous condition.

The customer had previously carried out localised repairs using alternative concrete repair materials. These products, however, were not effective due to poor adhesion and the nature of the coastal environment. An inspection of the Belzona repairs was carried out after 5 years and there is no signs of deterioration or damage to the step nosings.

1. Steps before repair
2. Immediately after repair
3. Steps after 5 years use
4. Close up showing no deterioration after 5 years.

Application was carried out in accordance with Belzona Know-How System Leaflet FPA-1.

Belzona 4131 (Magma Screed)
