# BELZONA REPAIRED STEPS IN GREAT CONDITION AFTER 5 YEARS (2)

Promenade steps on coast needing repairs.

Belzona 4131 (Magma Screed)

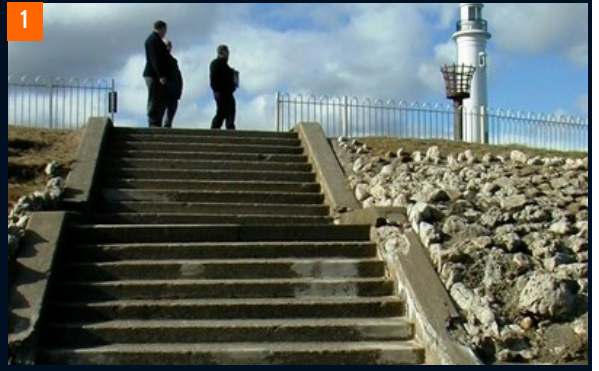
Due to the promenade steps being on the sea front, over a number of years they had deteriorated where the nosings were damaged and in dangerous condition.

1. Steps before repair in May 2005
2. Steps immediately after repair in May 2005
3. Steps five years on in May 2010
4. Further view of steps after five years service.

Application was carried out in accordance with Belzona Know-How System Leaflet FPA-1.

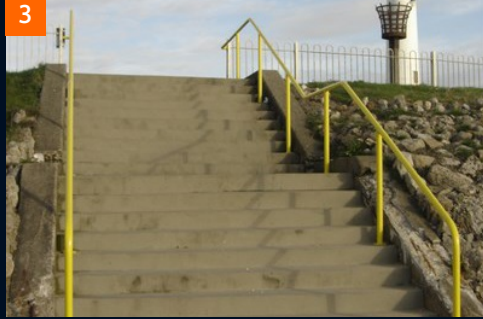
The customer had previously carried out localised repairs using alternative concrete repair materials. The products, however, were not effective due to poor adhesion and the nature of the coastal environment. An inspection of the Belzona application was carried out after 5 years and there is no signs of deterioration or damage to nosings whatsoever.
