# BELZONA REPAIR AND PROTECTION OF REFRIGERANT COMPRESSOR

ID: 146

Intercooler unit on a tugboat

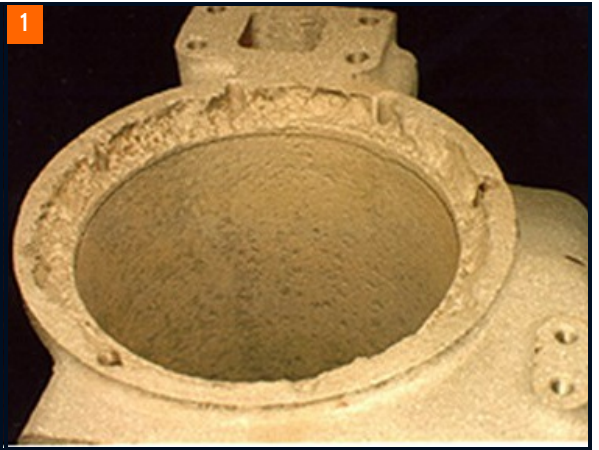
Severe erosion-corrosion particularly around flange faces, mainly by bimetallic corrosion.

1. The degree of metal wastage clearly evident
2. Profiles rebuilt with Belzona 1111
3. Complete protection provided by Belzona 1321 coating
