# BELZONA SIMPLIFIES REPAIRS IN GLASS LINED REACTORS

ID: 147

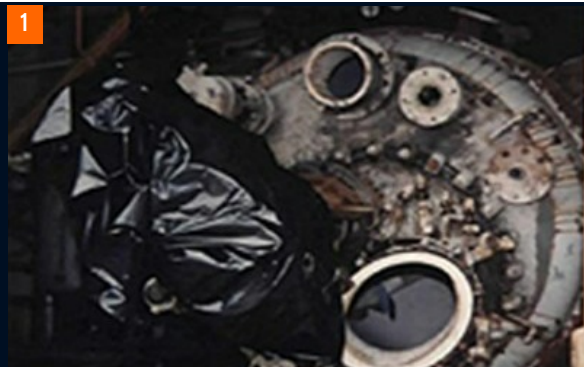
Damage to the glass lining caused by mis-handling of the covers and introduction of foreign bodies into the mixing process.

1. General view of the reactor
2. Typical damage to glass lining on cover
3. Repairs to cover being made. Note use of mixing board to form smooth surface on Belzona 1311
4. Local repairs with Belzona 1311 to damaged glass protection on mixer shaft

The Belzona repair can be completed in three hours. Making and securing Tantalum patches can take several days. Belzona® 1311 is only viable repair on agitator, Tantalum patches cannot be secured.
