# RESEATING NEW RUDDER BEARING WITH BELZONA

ID: 1478

Installation of new bronze bearing in oversized bearing housing.

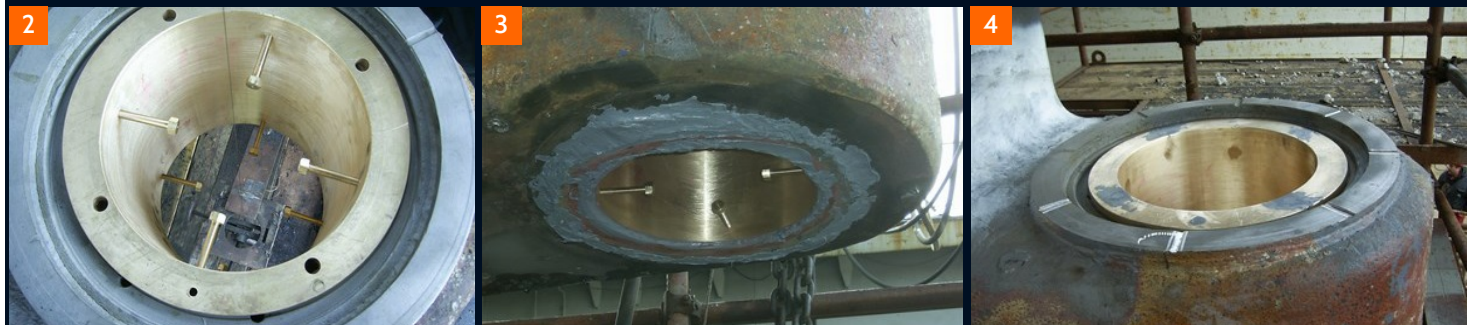
Corrosion damage and severe wear led to destruction of the old bearing and irregular form of the housing leading to increased annular space between the new manufactured bearing and the housing.

1. Bronze bearing machined and ready to be inserted in to the housing
2. Centralizing of the bearing in progress
3. Bae of bearing sealed with Belzona 1221
4. Finished application after injection of Belzona 1321

Application was carried out in accordance with Belzona Know-How System Leaflet SOS-9. The injection was through flexible hose placed into the four channels made in the back of the bearing.
