# REFORMING OF TRANSOM FLANGE WITH BELZONA

ID: 148

Jet thrust propulsion system on high-speed ferry operating between UK and Ireland

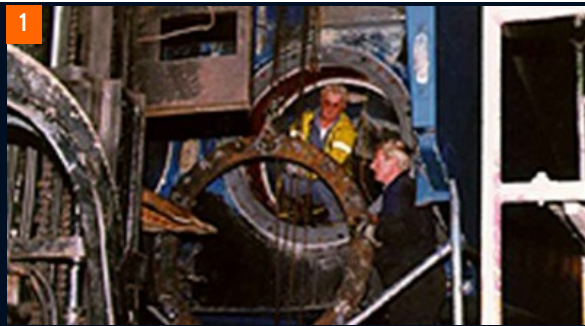
1. The forming ring being positioned
2. Injection of Belzona 1321 underway
3. The perfectly formed flange face awaiting removal of corks
4. The jet bowl waiting to be installed

The Transom was distorted by welding following repairs. Jet bowl no longer mated accurately with transom flange.

Application was carried out in accordance with Belzona Know-How system GSS-9.
