# BELZONA REBUILT CUTWATER EDGE OF COOLING PUMP

ID: 1481

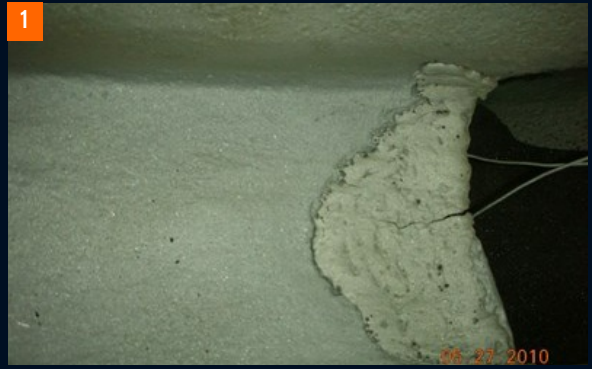
1. Cutwater after grid blasting
2. Preparation of cutwater framework for screwing steel mesh
3. Cutwater profile restoration with Belzona 1311 in progress
4. Completed application with two coats Belzona 1321
